## **Final Report**

# **NON-DESTRUCTIVE BRIDGE TESTING AND MONITORING WITH ACOUSTIC EMISSION (AE) SENSOR TECHNOLOGY**

**Hampton University**

**Eastern Seaboard Intermodal Transportation Applications Center  
(ESITAC)**

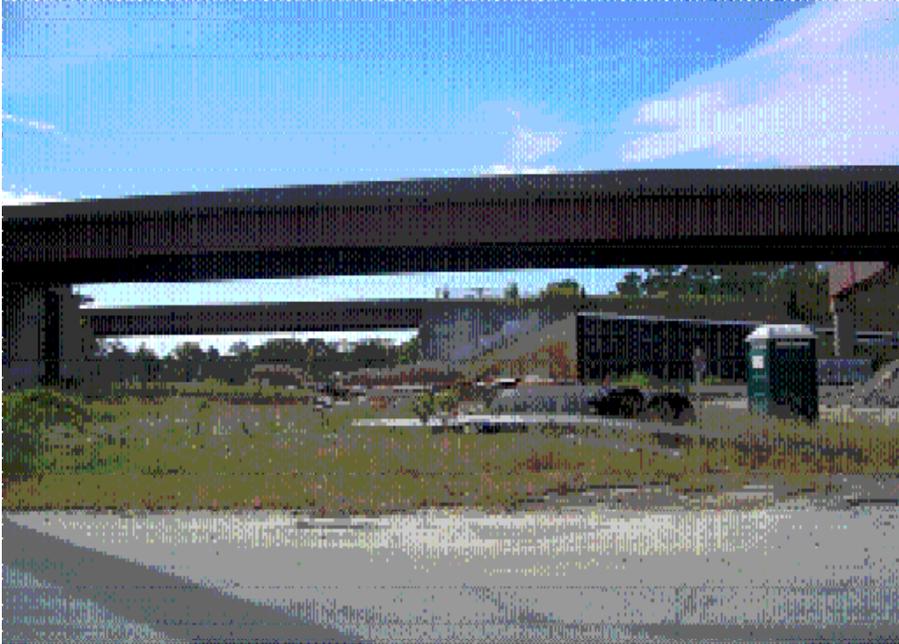
Such bridges use steel girders and devices such as pin and hanger assemblies as well as concrete in their structure (Figure 2). The structural plans of the two spans of the test bridge are shown in Figure 3.

Figure 2: Bridge girders at the tasked object.

Some of the problems with the pin and hanger assembly are attributed to deficiencies resulting in forces that were not accounted for in the bridge design. The hangers or links are designed for pure tensional forces. However, in practice, links are both tension and bending. Both in-plane and out-plane bending affect the bridge structure and its performance.
